The Influence of Environmentally Assisted Aging on the Degradation of a Carbon-Epoxy Composite

James Philip Smith (10558105) | BENG (Hons) Mechanical Engineering with Composites
 School of Engineering, Computing & Mathematics | Faculty of Science & Engineering | University of Plymouth
 Supervisor: Dr Alistair Cree | May 2021

Project Aim

To evaluate the potential changes in the mechanical properties of a carbon-epoxy composite when subjected to a range of environmental conditions of different time periods.

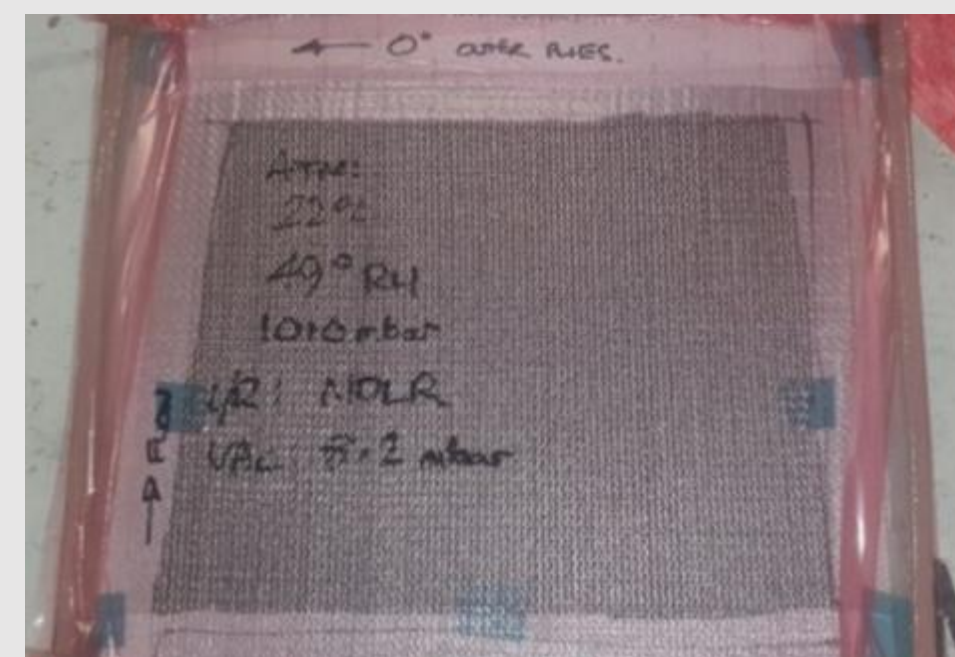
The composite laminate was manufactured using twill carbon fibre cloth infused with IN2 epoxy resin | *Figure 1*.

- These constituent materials were infused using a resin infusion under flexible tooling (RIFT) manufacturing method.
- This laminate was left under a vacuum pressure of 10.1 mbar for 48 hours to ensure maximum infusion.
- Specimens were then cut from this laminate sheet using a Tyslide diamond saw.

Figure 1: Manufactured RIFT Laminate Panel

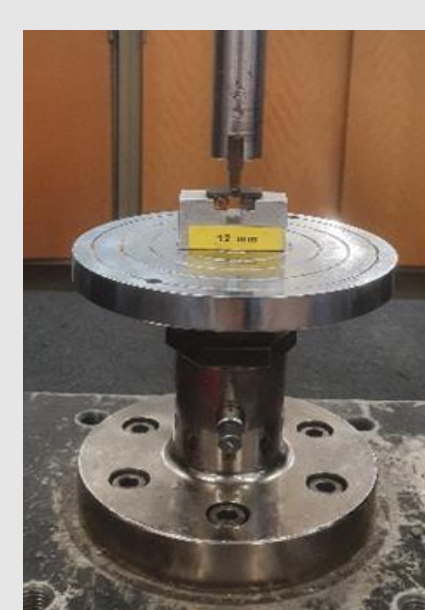
Figure 2: ILSS Testing Equipment

- Interlaminar Shear Strength Test (ILSS) | *Figure 2*.
- 3-point Flexural Test | *Figure 3*.
- Vickers Hardness Test.
- 6 Decimal Place (DP) Scales.

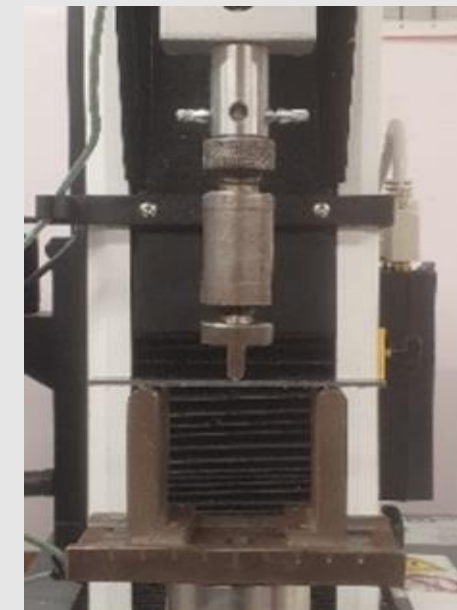
Figure 3: 3-point Flexural Testing Equipment

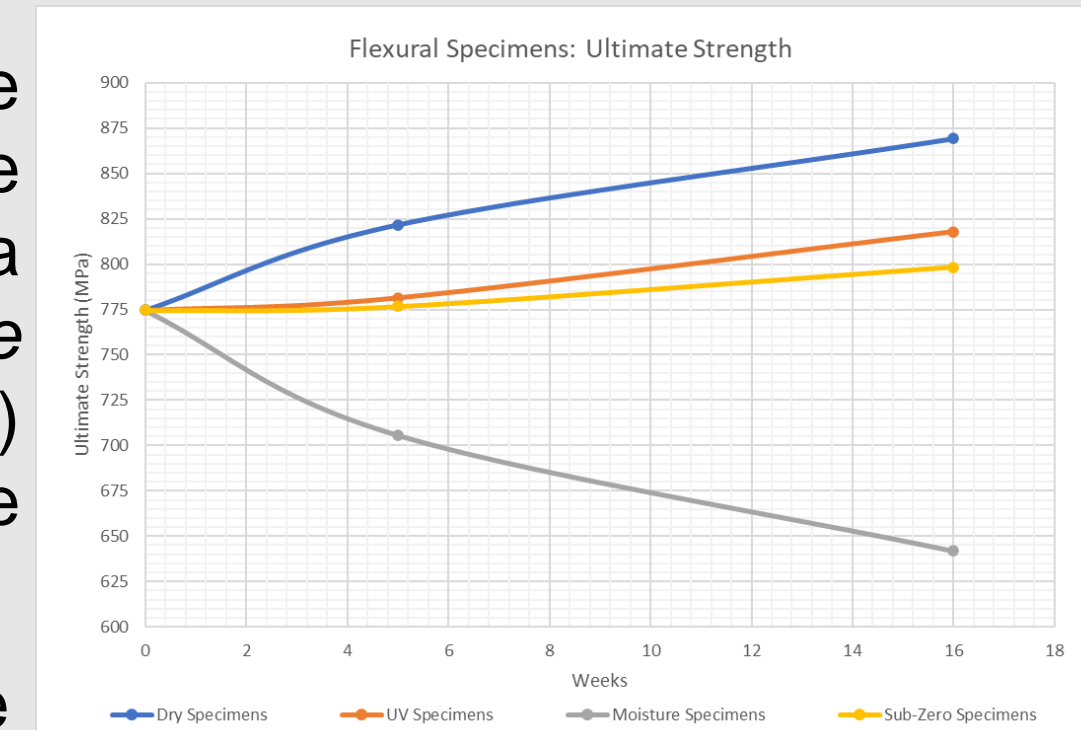
3-Point Flexural Specimens: The results obtained for the flexural specimens compares the change in ultimate tensile strength of the composite over the 16-week period, this data was compared to dry baseline samples. As shown in | *Figure 4* | the dry specimens ultimate tensile strength (UTS) increased by 12.2% over the 16-week period, whereas the moisture specimens UTS decreased by 26.2%

Figure 4: Recorded Ultimate Tensile Strength for 3-point Flexural Specimens

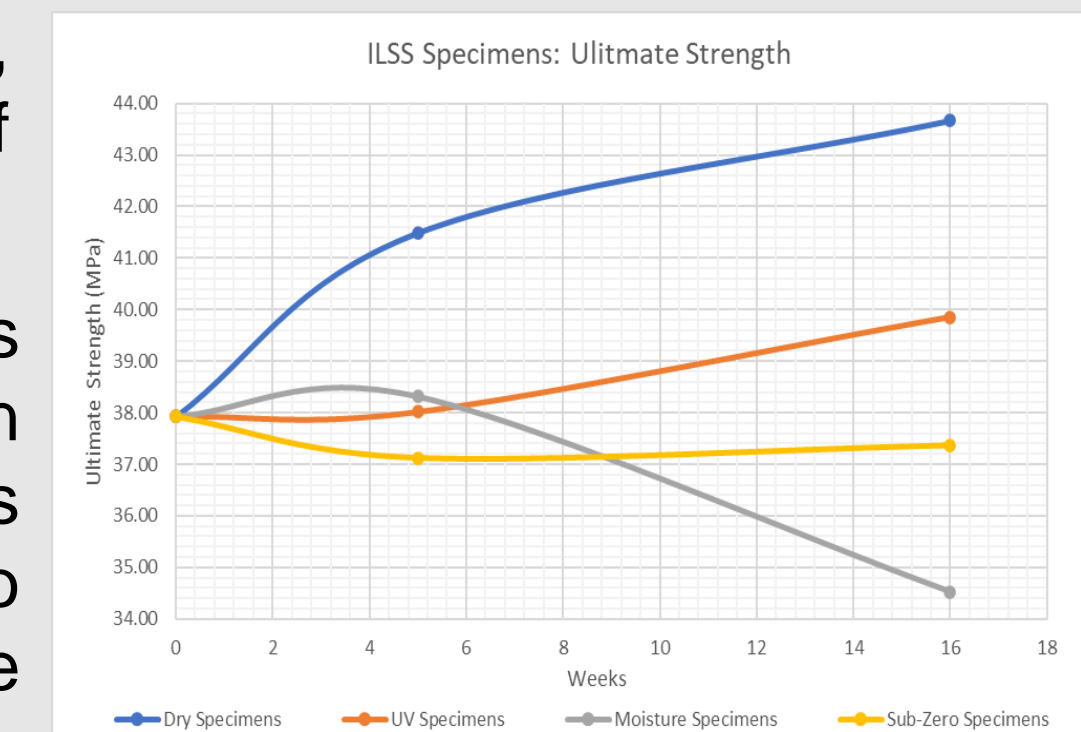
ILSS Specimens: The ILSS specimens followed the same formation as the flexural specimens, increasing the overall reliability of the results | *Figure 5* |. Furthermore, the results obtained in this report followed that of relevant literature, when compared to (Zaoutsos & Zilidou, 2017), a difference of 5% in UTS was noticed.

Figure 5: Recorded Ultimate Tensile Strength for ILSS Specimens
